Five-Year Review Report

Third Five-Year Review Report for Hollingsworth Solderless Terminal Company Ft. Lauderdale Broward County, Florida

December 2005

United States Environmental Protection Agency
Region 4
Athens, Georgia

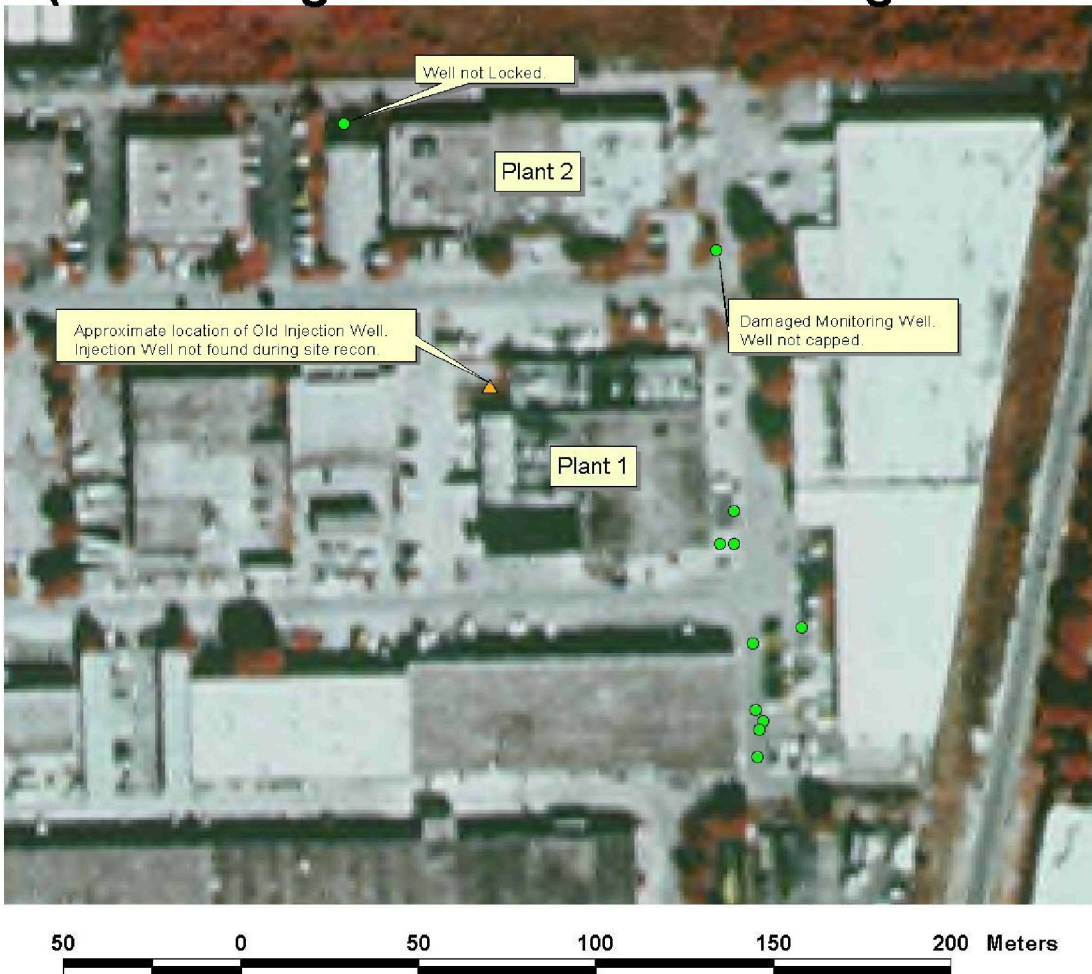
**Figure 3: HSTC
(Monitoring wells observed during Site Inspection)**

Operation and Maintenance (O&M) of the monitoring well network needs to start incorporating more inspection and maintenance and repairs of these wells. Some wells heads were found during the site inspection to be unlocked, missing bolts to the wellhead, and in one case even damaged to the point of being open /uncapped and at risk to indiscriminate dumping of wastes. The site is located within the 100 year flood plain and is topographically flat. As such, heavy rains or floods present a risk to the wellheads if they are not more periodically inspected and maintained. The damaged well (see Figure 9) needs to be properly abandoned or repaired. Additional resources may be freed for the O&M program for these activities by locating low value monitoring wells and abandoning them.

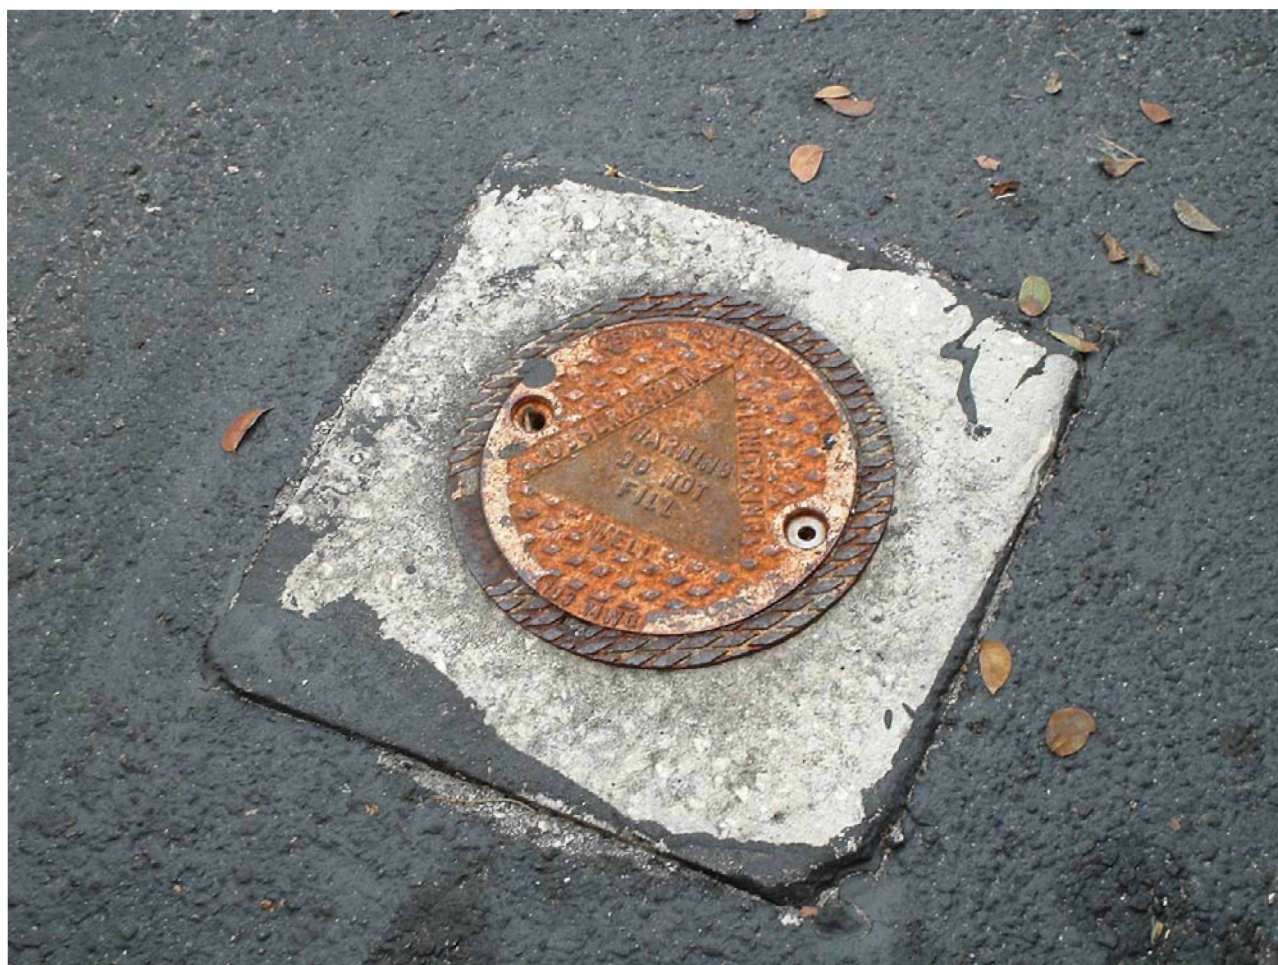
FIGURE 6

Monitoring well found in good shape. However, the well is not clearly labeled and the cover plate for the wellhead is not bolted down.

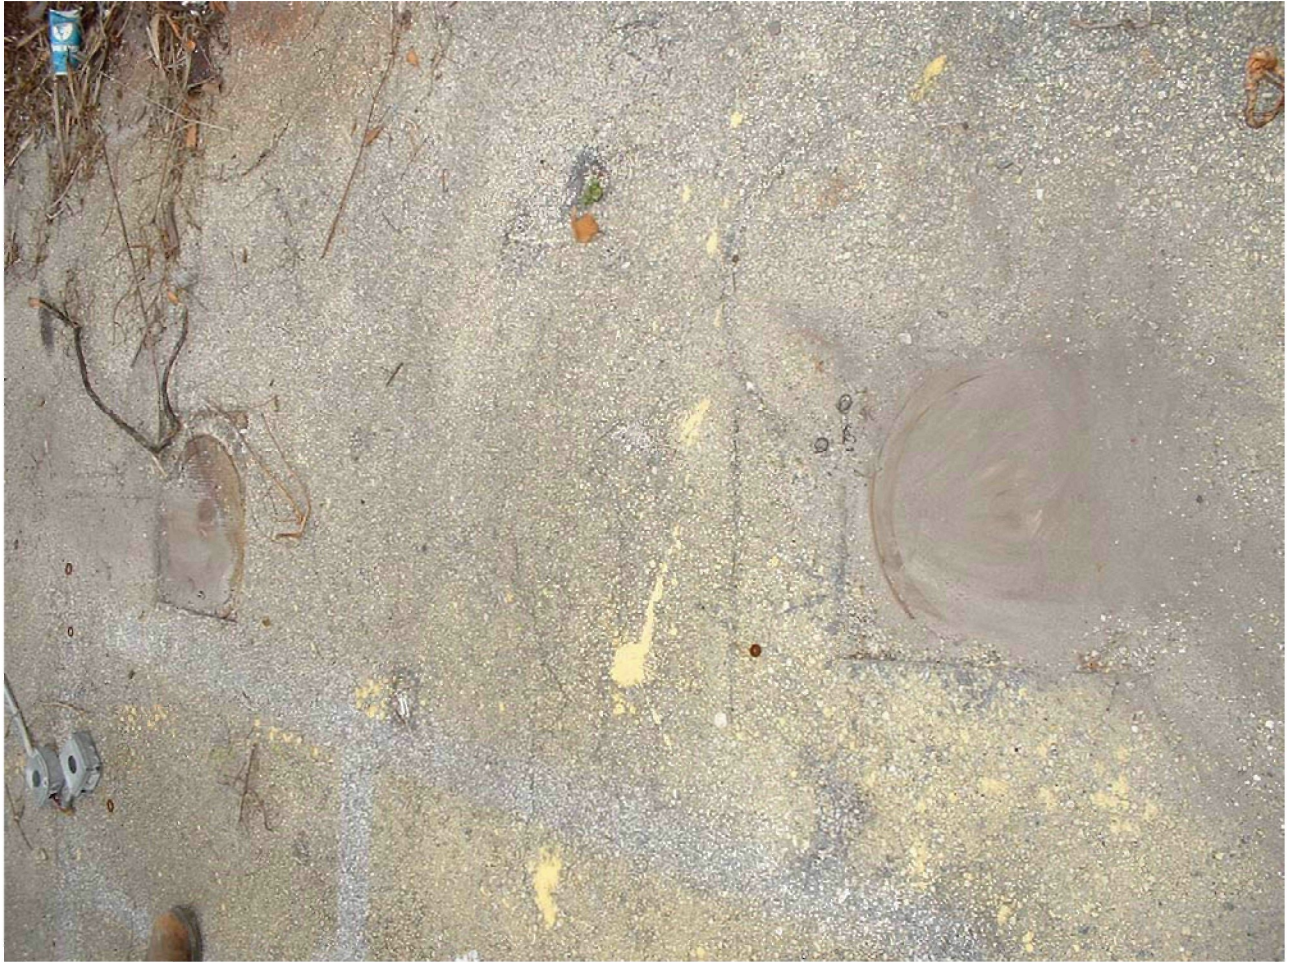
FIGURE 7

Monitoring well cluster, flush mount. Wellheads are covered with dirt and debris. Wells are not clearly labeled. Wellheads should have been constructed to be mounded so that surface water runoff from the parking lots would not collect over the well heads.

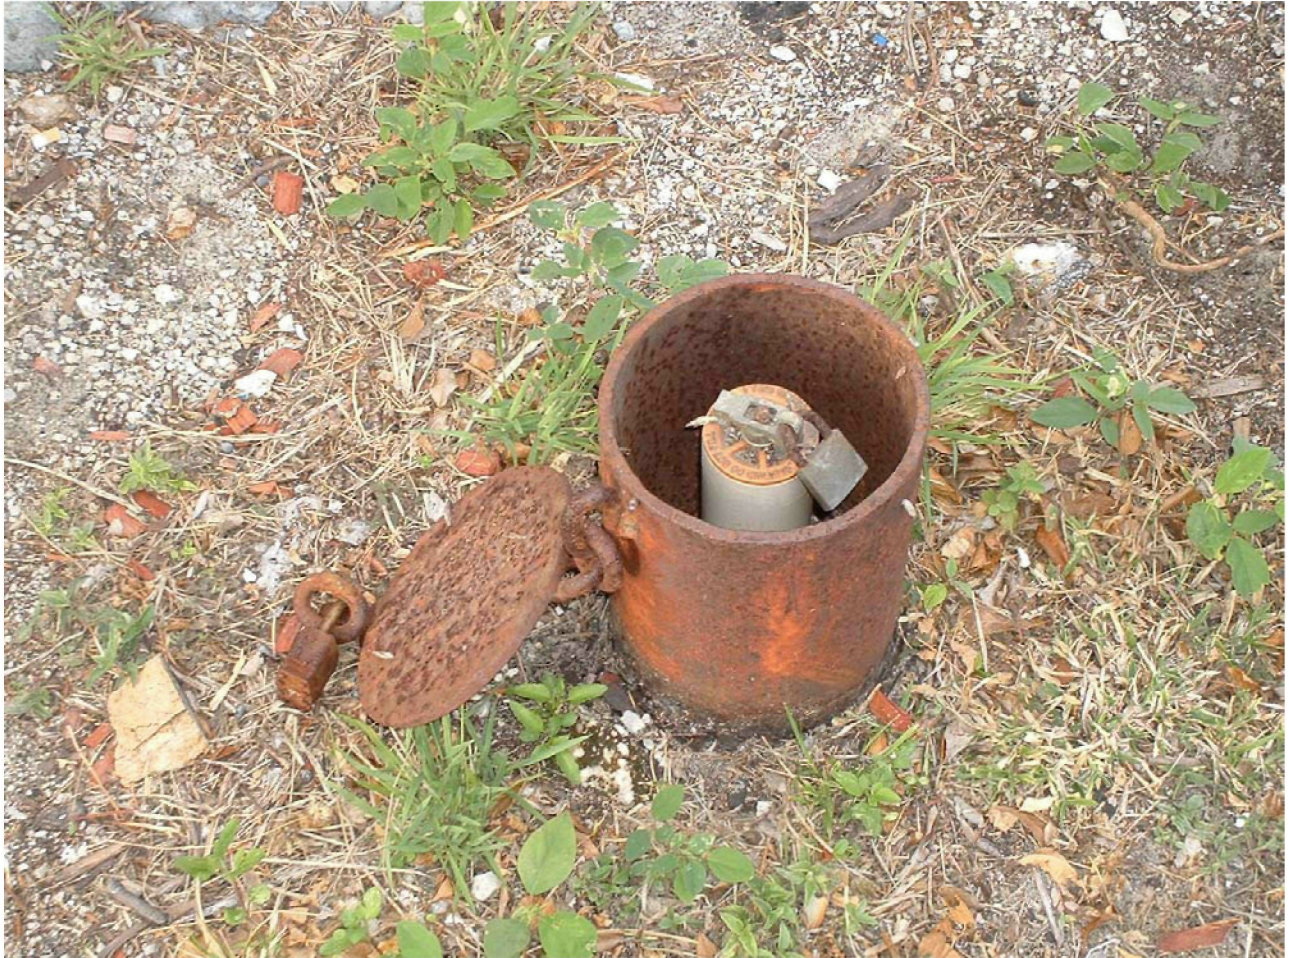
FIGURE 8

Monitoring well located in a fenced area to the west of Plant #2. Well head is not locked, however the well is capped. Location of well suggests that it is probably one of the 7 series wells, however, the well is not clearly labeled. Coordinates for this well are:
UTM Zone 17, Northing 2,897,849, Easting 584,611, NAD 1927.

C) Groundwater monitoring wells need additional O&M (see Figures 8 and 9).	Recommend more routine inspection and maintenance of the wellheads at the HSTC Site. Some wellheads have been constructed in a manner that will allow surface water runoff from the parking lot and roads in this industrial area to pool over the wellheads, i.e., the wellheads are not mounded to repel surface water. If these wellheads are not properly secured with bolts and gaskets then this is a potential source for contamination from the surface to the groundwater.	EPA		06/30/2006	N	Y

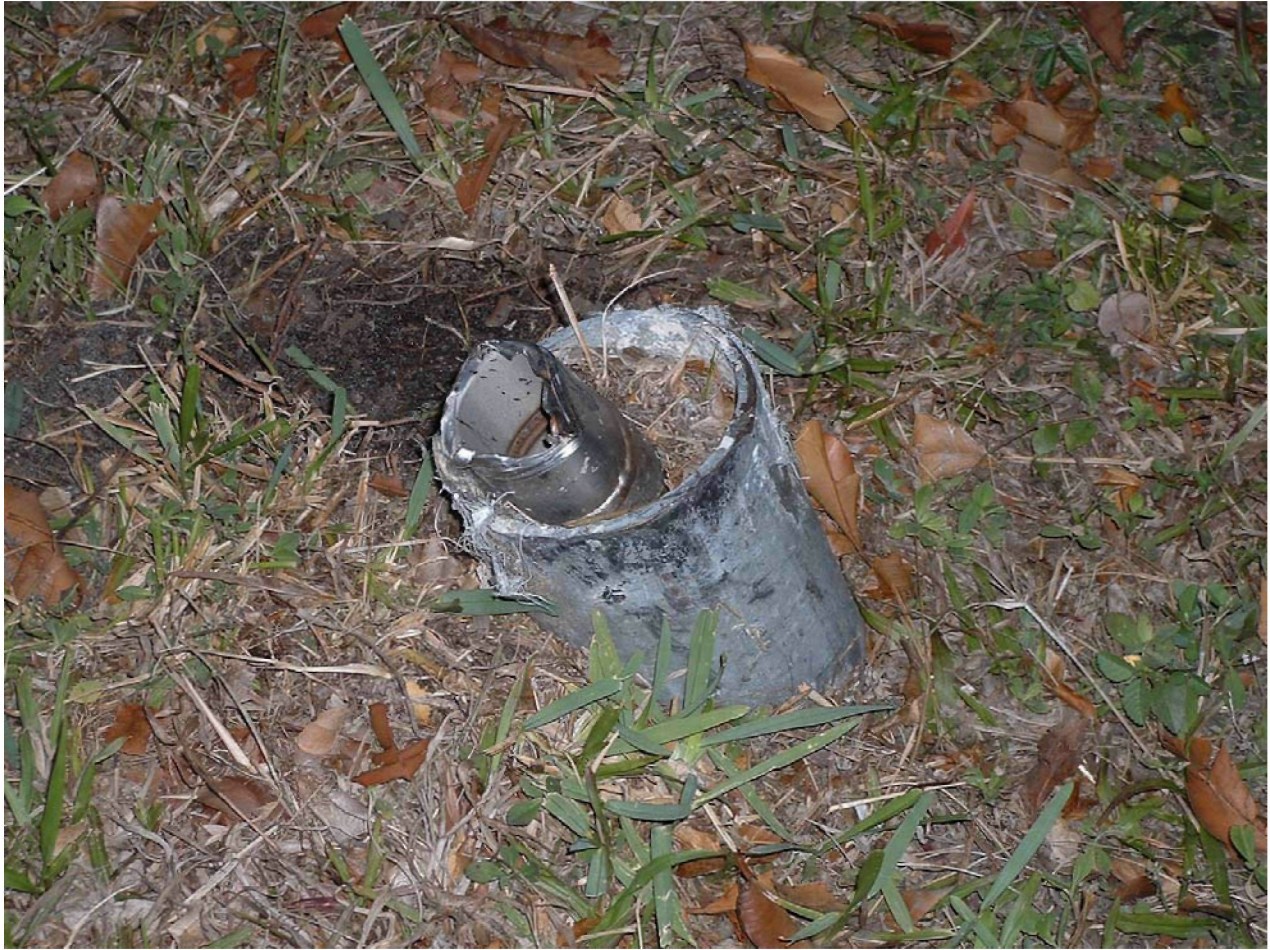
FIGURE 9

Issue	Currently Affects Protectiveness (Y/N)	Affects Future Protectiveness (Y/N)
<p>F) A monitoring well located at the southeast corner of the property of Plant #2 was found to have a damaged wellhead (see Figure 3 for location and Figure 9 for photograph). This well may possibly be monitoring well XD. However, due to the wells not being clearly marked this identification can not be certain. This monitoring well appears to have been run over by a heavy vehicle or possibly damaged by a large lawn mower. Due to the well being unlocked and not capped, this well could be acting as a conduit for contamination from the surface to the groundwater. Additionally, like the old injection well cited in Weston's 1996 first Five-Year Review report, this well could also be acting as a conduit for cross contamination between zones due to the integrity of the well casing being in question. This well is located at UTM Zone 17, Northing 2,897,813, Easting 584,716, NAD 1927.</p>	Y	Y

Monitoring well located on the southeast corner of Plant #2 property lot. Well appears to have been damaged by a large vehicle or perhaps a large lawn mower. Damaged wellhead is cut/bent off and is not capped or locked. Integrity of stainless steel well casing below the ground surface is in question. Well should be properly abandoned. Coordinates for this well are: UTM Zone 17, Northing 2,897,813, Easting 584,716, NAD 1927.

Issue	Recommendations/ Follow-up Actions	Party Responsible	Oversight Agency	Mile- Stone Date	Affects Protectiveness? (Y/N)	
					Current	Future
<u>D)</u> Groundwater monitoring wells are not clearly marked.	Recommend clearly labeling wellheads with identifying markings for the groundwater monitoring network at the HSTC Site.	EPA		06/30/2006	N	N
<u>E)</u> Monitoring well found unlocked and appeared to have been left un-attended for some time (see Figure 3 for location and Figure 10 for photograph)	Recommend properly securing a monitoring well located to the west of Plant 2, probably one of the 7 series cluster. The monitoring well is located at UTM Zone 17, Northing 2,897,849, Easting 584,611, NAD 1927. Increase inspection and maintenance in the (O&M) program for this HSTC Site.	EPA		06/30/2006	N	Y
<u>F)</u> Damaged wellhead.	Recommend properly abandoning a monitoring well located at the southeast corner of Plant #2's lot. The wellhead for this monitoring well has had its stainless steel casing sheared off and is now un-secured and un-capped. Due to the well casing being torqued/bent over, the integrity of the well casing is in question. Until properly abandoned, this well is a potential for both contamination from the surface to the groundwater via indiscriminate dumping of wastes down the un-capped well; and also by cross contamination between zones due to the well casing being in question. This well is located at UTM Zone 17, Northing 2,897,813, Easting 584,716, NAD 1927.	EPA		06/30/2006	Y	Y
